# **Helios Prototype Vehicle Mishap: Technical Findings, Recommendations, and Lessons Learned**

**John Del Frate  
NASA Helios Project Manager**

**September 10, 2008**

**High Altitude Long Endurance,  
Non-Linear Aeroelastic Tools Workshop  
Alexandria, VA**

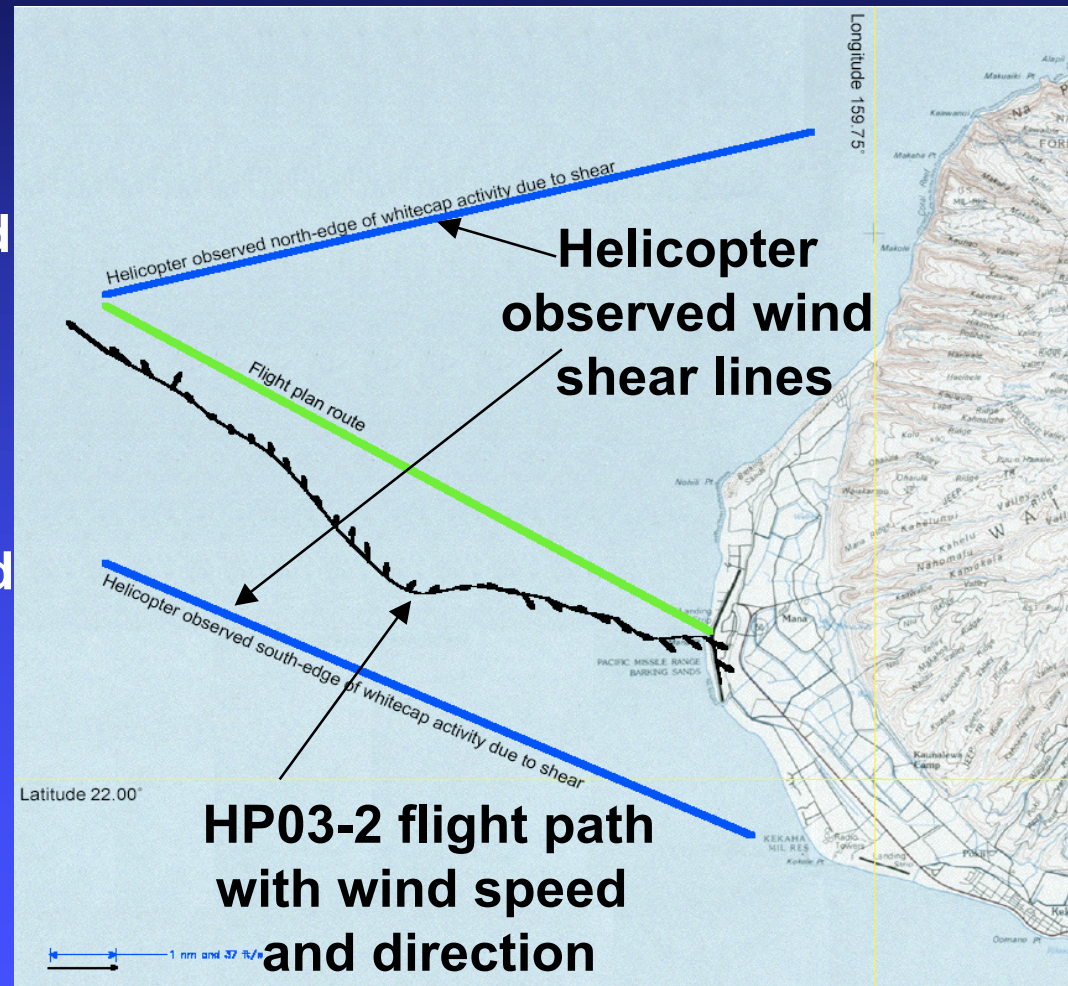
# Turbulence Shear Line Observations

Northern wind  
shear line

Southern wind  
shear line

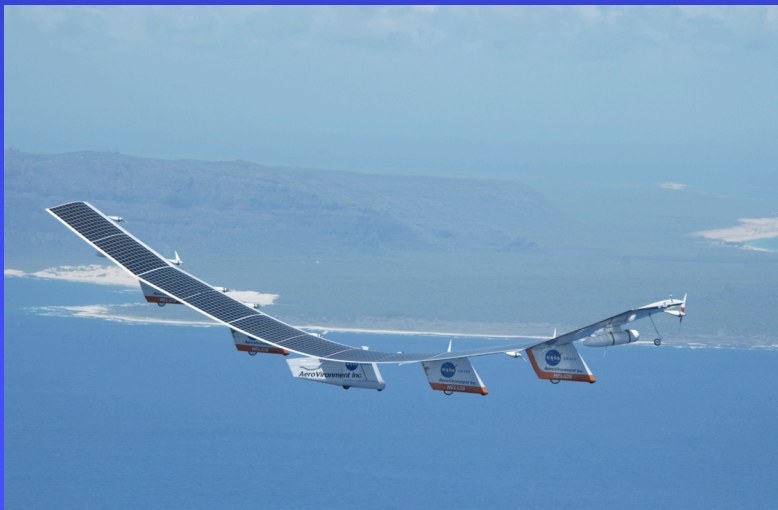
HP03-2 with normal wing dihedral

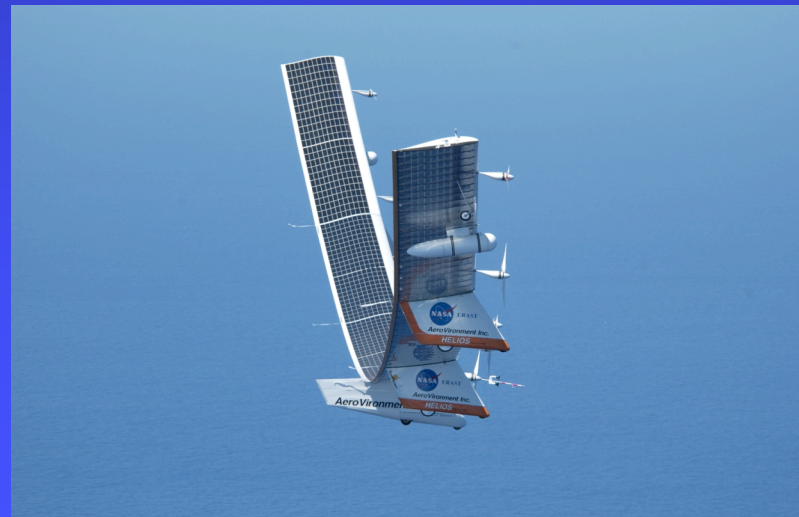
HP03-2 with persistent high wing dihedral

- On June 26, 2003 at approximately 10:35am at an altitude of about 2,800 feet, HP03-2 encountered turbulence associated with wind shear lines around the island of Kauai
- Turbulence initiated a persistent high wing dihedral causing an unstable pitch oscillation
- Airspeed excursions were around  $\pm 2$  ft/sec; main wing spar strain gauge reading 103% of limit load
- Following pilot procedures to reduce dihedral, wing dihedral decreased slightly, but then grew to over 30 feet
- Large airspeed fluctuations of about  $\pm 10$  ft/sec now observed, an indication the aircraft was experiencing large pitching motions
- Airspeed excursions began to double every cycle

- Develop a method to measure wing dihedral in real-time
- Develop manual and/or automatic techniques to control wing dihedral in flight
- Develop capability to perform simulations of the vehicle's response to disturbances
- Apply advanced atmospheric models that better predict conditions hazardous to this class of vehicle

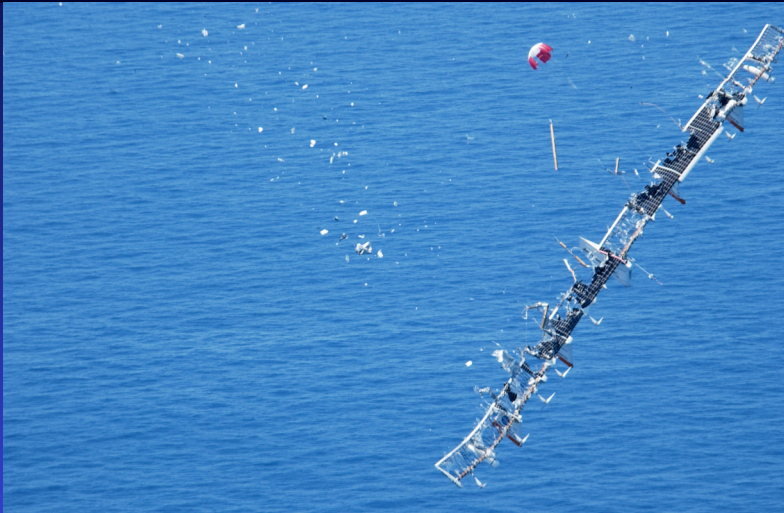
- Vehicle became oriented at extreme attitudes relative to the air stream (wing dihedral of about 40 feet with the airspeed nearing 90 ft/sec)
- High dynamic loads broke the right wing leading edge foam secondary structure near the hydrogen fuel tanks
- Solar cells and the wing skin began to rip off the upper surface of the wing resulting in loss of lift
- Vehicle entered a more severe attitude resulting in additional secondary structural failure
- Aircraft continued to come apart as it fell to the Pacific Ocean

**Falling to the Pacific**

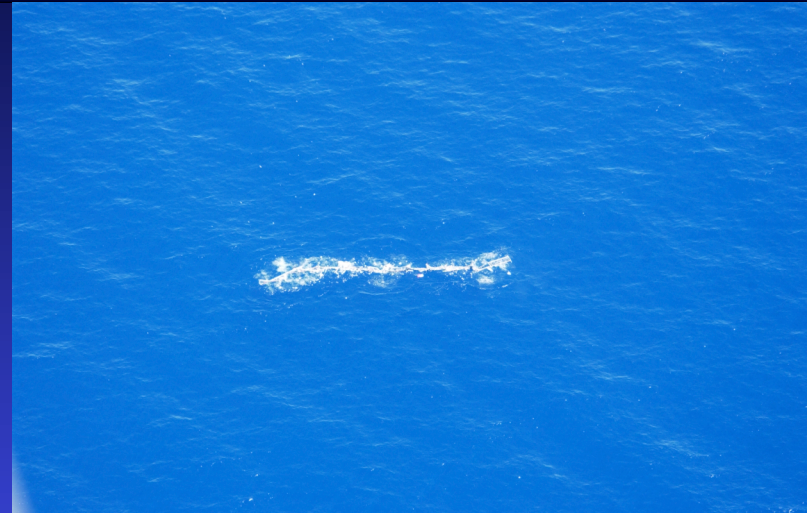
**Helios upon impact with the ocean**

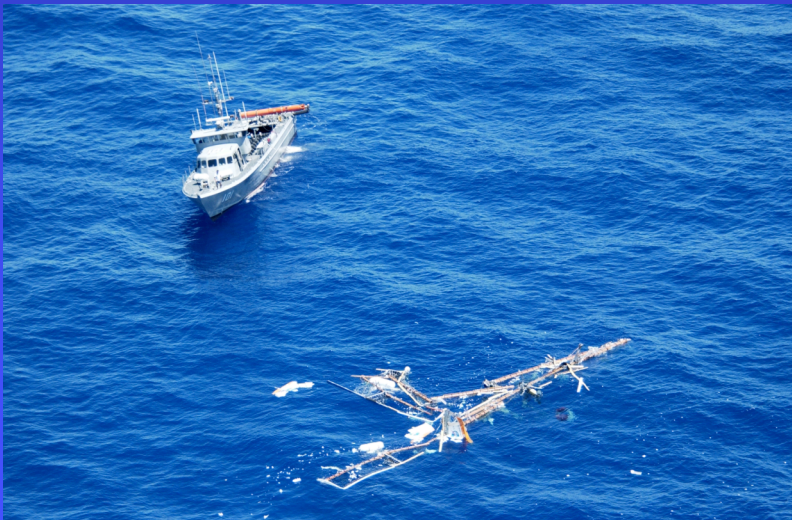
**Surveillance of debris**

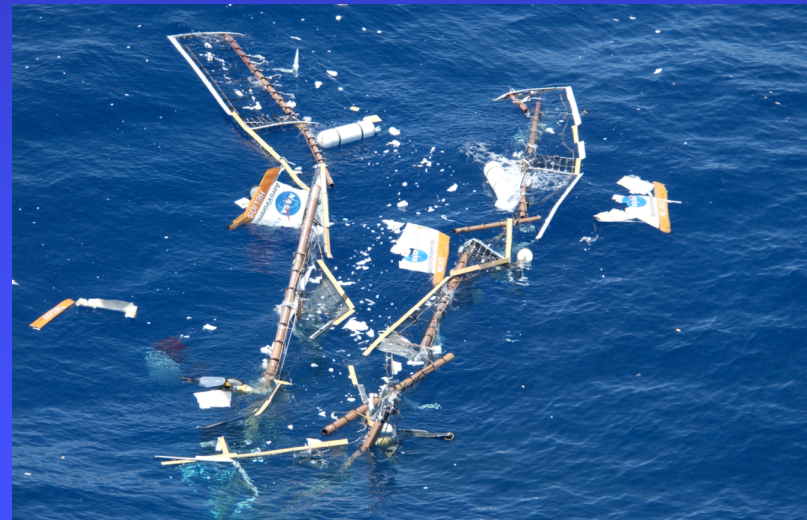
**Close-up of floating debris**
